**JOINT ACCESSIBILITY ADVISORY COMMITTEE MEETING**  
**Via Microsoft Teams**  
**Wednesday, December 8, 2021 at 6 pm**

# JOINT ACCESSIBILITY ADVISORY COMMITTEE

**level**  
**PLAYING FIELD**  
an accessibility agency

# WHAT WE OBSERVED

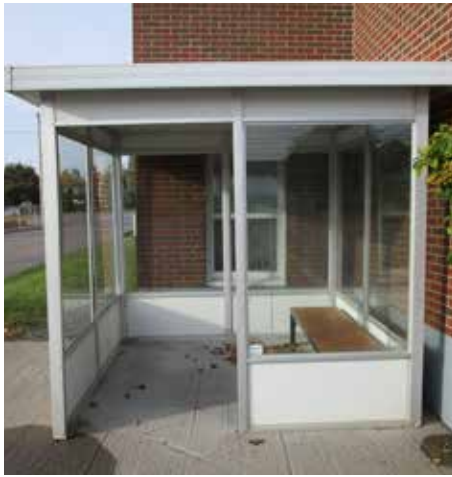
**TR 2 |** Bus Stop in Port Williams, No accessible space not in path of travel

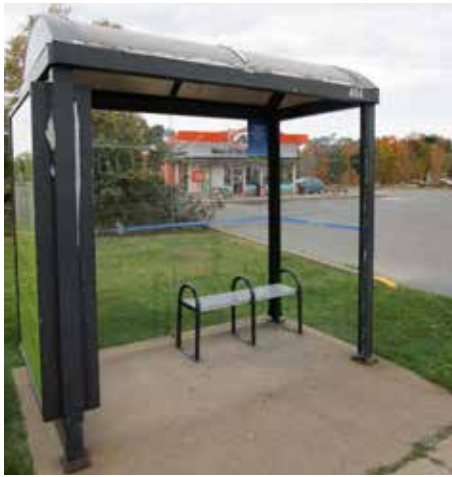
**TR 3 |** New Minas bus stop with accessible space next to bench

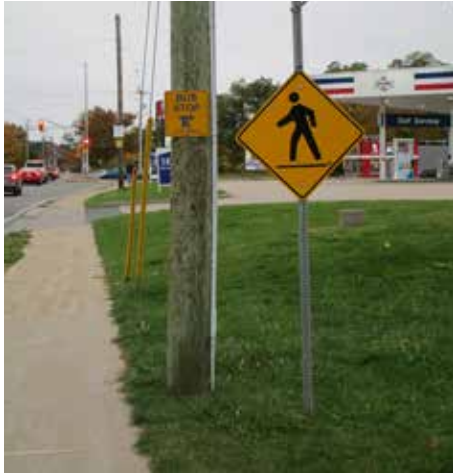
**TR 7 |** Village of Greenwood , bus stop sign on electrical post

Increase the size of bus stop signs so they can be read from a further distance and place consistently in all locations. Ensure that all signage is placed to avoid shadows and glare. Accessibility can be increased by providing the routes travel direction (ie. east) as well as a stop number. The stop number should correspond with website route information. It is also recommended that additional signage be provided that includes tactile characters and braille.

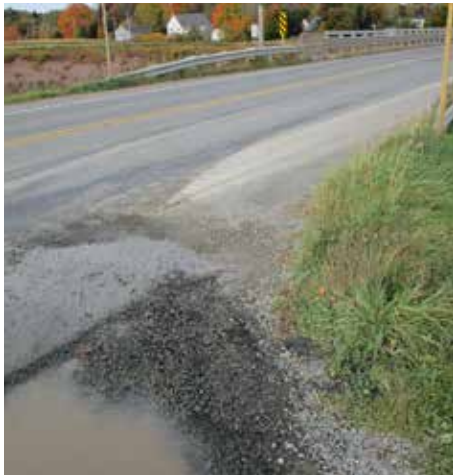
**PS 2 |** Pot holes leading to Port Williams bridge

The pedestrian pathway to the bridge is not level and made up of loose gravel. It then leads the user to traverse the path of live vehicle traffic. The path crossing the Port Williams bridge marginally meets some accessible standards. The ramp to the path is present, but is far too steep. There is no colour contrasting stripping along the path to indicate an abrupt change in grade. The pathway itself is too narrow and only permits a single lane. If two wheeled mobility devices met on this path one would have to back up and off the path. Tactile warnings are also needed before the ramps to insure users with limited vision are aware of the grade change.

Bridge crossings are currently inaccessible. Paved pathways end prior to bridge crossings and people are forced to traverse the roadway and gravel to get to the bridge sidewalk. The bridge sidewalks are too narrow for even a single wheelchair to use and a steep, asphalt ramp is provided to access them. The Port Williams bridge was covered in road gravel at the time of our visit, making it very slippery. LPF recommends widening the sidewalk and providing a color contrasted warning strip along the curb edge to warn of a drop into the roadway. A guardrail on the road side of the sidewalk can be used in future construction to increase safety.

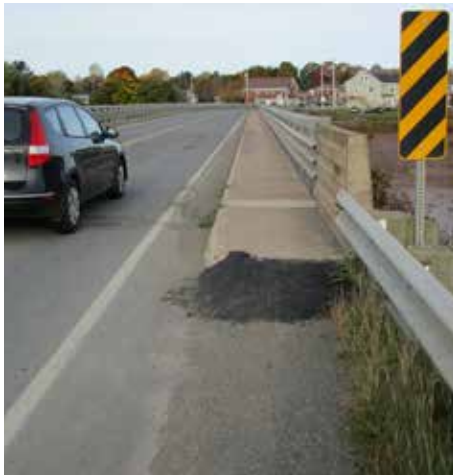
**PS 3 |** Ramp to path on Port Williams bridge

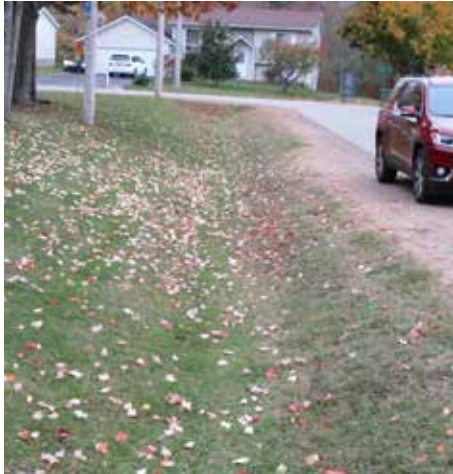
**PS 4 |** Lack of sidewalks forces users to walk along an active roadway

The lack of sidewalks in residential areas forces users to walk along the road or ditch. It was observed that when parked on the side of the road pedestrians would have to choose between walking in the ditch or on the active road.

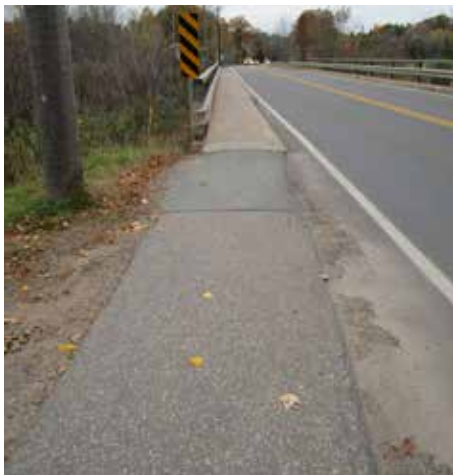
**PS 5 |** Single pathway with ramp crossing Kingston bridge

The Kingston bridge is in need of an accessibility and pedestrian retrofit. The sidewalk is on an elevated platform and only accessible from steep ramps. No colour contrasting strip is found on the curb edge where it drops to roadway. If two users in wheeled mobility devices would enter the pathway from opposite end one would have to back up to let the other through.

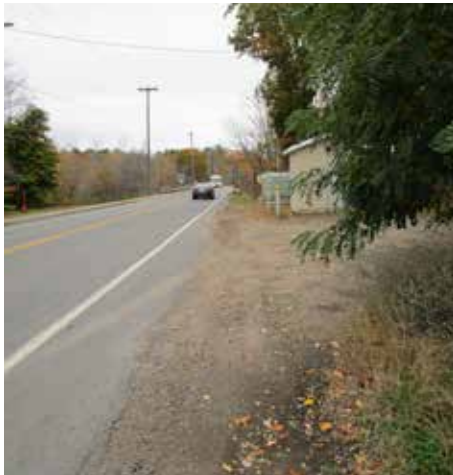
**PS 6 |** Loose gravel path that terminates at Kingston bridge

The pathway leading up to the Kingston bridge is uneven and loose ground surface does not encourage accessible travel. In addition to the poor pathway conditions there is no designated crosswalk. A lack of crosswalk requires all pedestrians to navigate across active traffic to get to the side of the bridge with a sidewalk.

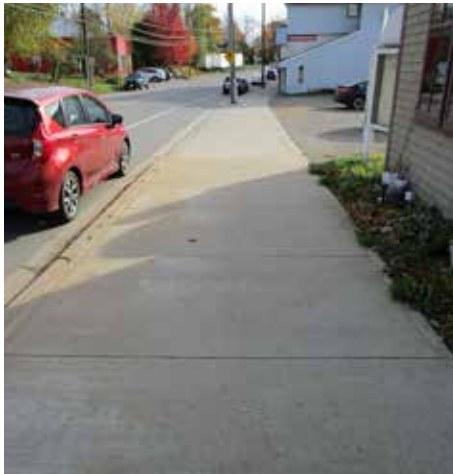
**PS 7 |** Canning sidewalk that is wide enough for two wheeled mobility devices

The sidewalk seen in image PS7 is a good example of how a sidewalk should look. The sidewalk is wide enough to accommodate passing and any obstructions in the path do not reduce the width down to an inaccessible width.

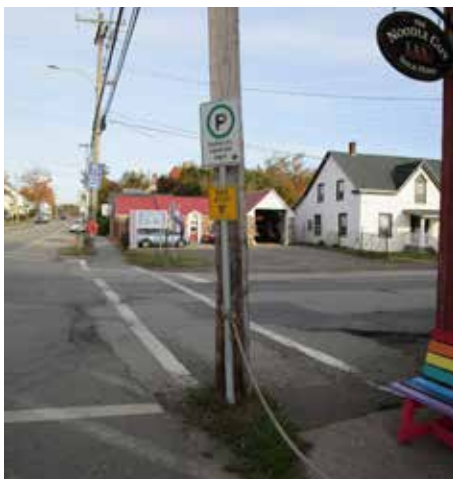
**PS 8 |** Sidewalk in Port Williams is restricted by obstacles along the sidewalk

This crosswalk presents the current state of accessibility in Kings County. The bus bench restricts access to the crosswalk due to its location on the sidewalk. The crosswalk path is not a single surface and does not have any tactile warnings before to indicate entrance into a roadway. There are no flashing lights or auditory signals to notify vehicle traffic or pedestrians respectively. Finally, vertical signage is not present to indicate a road crossing.

A colour-contrasted, textured strip at least 50mm in width should be placed at locations where grade changes occur in the pathway. Curb cuts with tactile walking surface indicators should be provided at all cross walks. Visual and audible signals should be provided at crossings to help direct both pedestrians and vehicles of the crosswalk. Many of the crossings we visited also had painted pavement and vertical signage for the crossing and it is recommended that the same is done for more of the intersections.

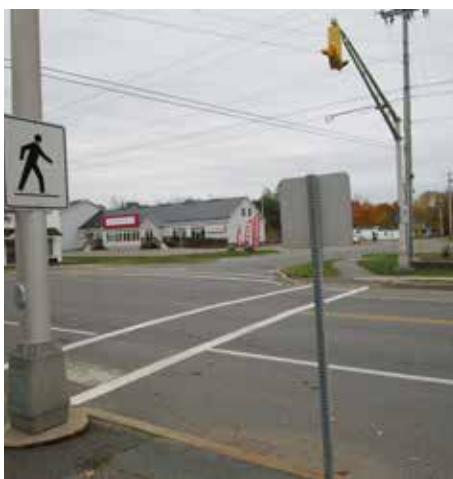
**PS 9 |** Updated crosswalk in Kingston

The crosswalk in image PS9 demonstrates an improvement to the pedestrian experience. With flashing lights and signage, oncoming vehicles are warned of pedestrians crossing. The crosswalk is still in need of tactile warnings to indicate an entrance into an active roadway.

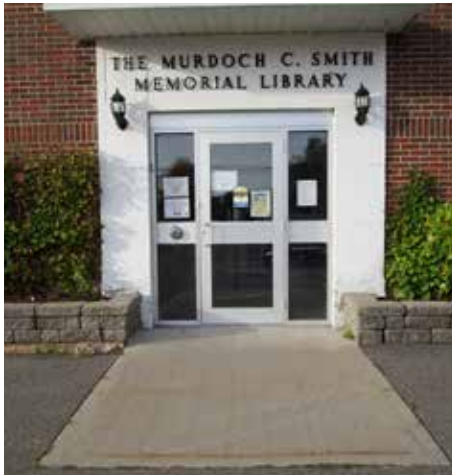
**KA 2 |** Accessible front entrance at the Memorial Library in Port Williams

This site has good access with a level platform at the entrance. The door is accessible and has a automatic opening button on the side wall. The button location could be improved, as it is within the swing of the door and users would likely get hit by the door once pressed. Lighting is good and the entrance provides shelter from inclement weather conditions.

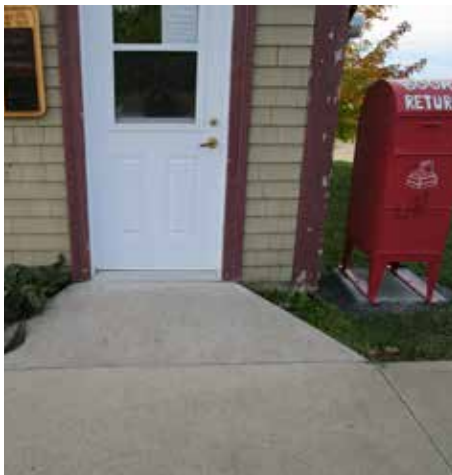
**KA 3 |** Canning Library with sloped access and inaccessible book return

This site has tried to increase accessibility of the entrance by adding a ramp to the door. The ramp is steep and does not provide a level landing at the top so that a user can manoeuvre the door. The door is also not equipped with an automatic opener. The after-hours book return is located off the level pathway and is over accessible height. The signage on the building is not colour contrasted and does not have any tactile characters on it. In addition the signage material creates glare making it hard to read from a distance.

All public building entrances should have a level landing at the door that can accommodate the turning radius of a wheelchair. Automatic door operators should be placed out of, but adjacent to, the door swing and no more than 1500mm from it. Where there are two doors, such as in a vestibule, ensure both open in unison once the automatic door control is activated. It is recommended that all accessible entrance doors, as well as accessible washroom doors, are equipped with automatic openers.

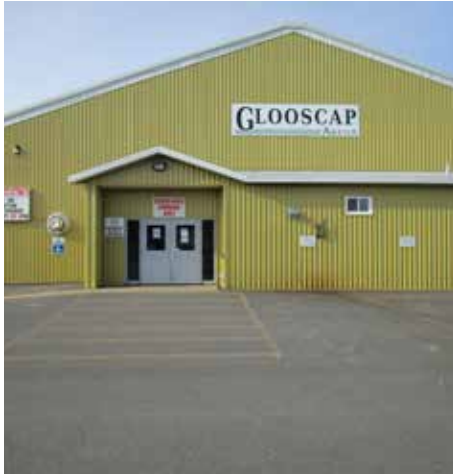
KA 4 | Front entrance to arena

This building has some good accessibility features. The front entrance is level and wheelchair accessible. Automatic door openers are provided and are located out of the swing of the doors.

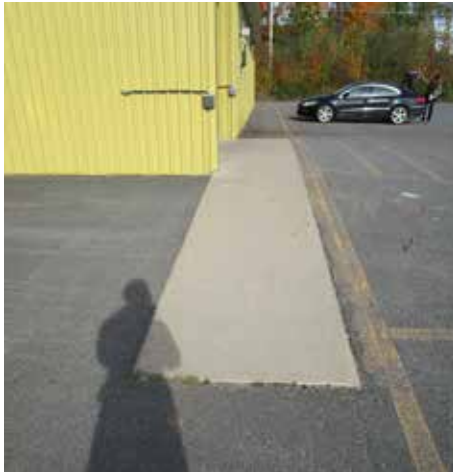
KA 5 | Accessible ramp to the south of the front entrance

The ramp on the south side of the entrance is provided for accessible access to parking stalls. The current ramp can present a tripping hazard for some users due to its lack of colour contrast. The lack of railing reduces way finding for those with reduction in visibility. In addition a railing would ensure that no vehicle could encroach on the accessible pathway when parking in the adjacent stall.

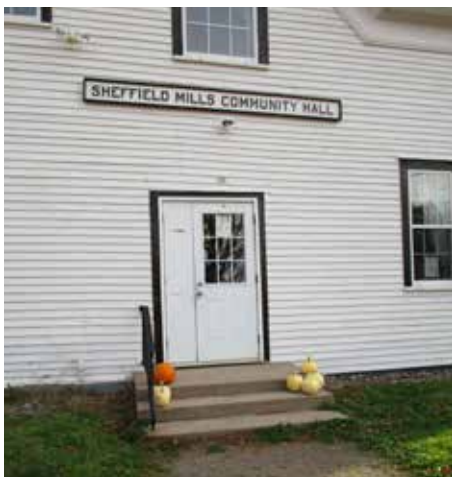
**KA 9 |** Stairs leading into the front entrance of the Sheffield Mills Community Hall

The Sheffield Mills community hall has accessibility limitations both physically and visually. The front entrance to the building requires a user to climb steps. The hall does have an accessible entrance, but it is located at the less desirable side of the building. In addition, the front door uses a knob door handle that requires full dexterity.

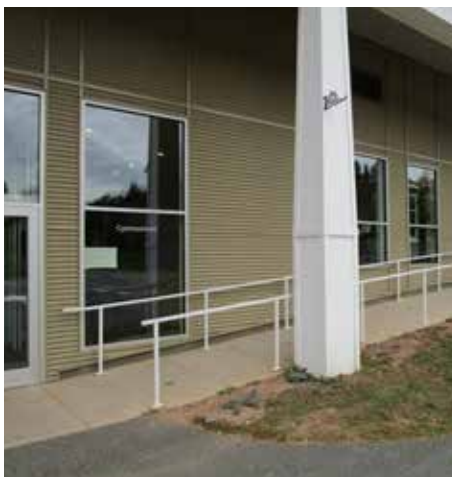
**KA 12** | Exterior ramp to access interior rooms within the village office

The community complex is two levels and doesn't have an interior elevator. An exterior ramp is provided but is not inclusive. The provided railing does not contain a lower rail which could cause harm to those in a wheelchair.

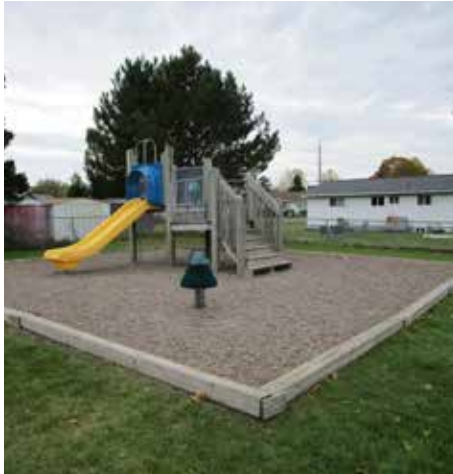
**KA 13** | Typical inaccessible playground found throughout county

This playground in New Minas shows the current state of many of the playgrounds in Kings County. With a wooden curb and pea gravel, the playground is not accessible. There is also no accessible playground equipment.

Playgrounds should have a level entrance and be free of curbs that limit access. The ground surface of playgrounds should be level and firm to promote interactive play between children of all abilities. Accessible equipment should also be provided at locations throughout the park (not only in one location). LPF recommends that the County websites highlight which playgrounds are currently accessible until upgrades can be done to the remaining sites.

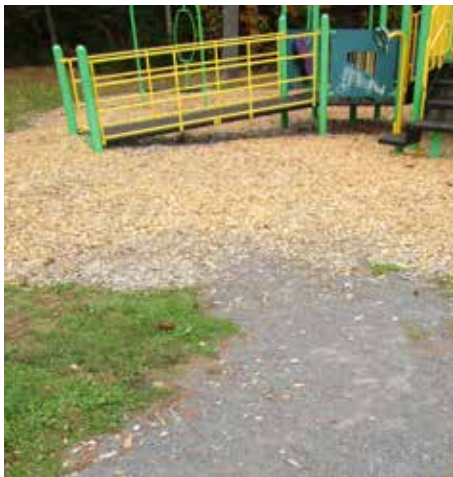
**KA 14** | Entrance path to accessible playground in Centreville

One of the County of Kings Accessible playgrounds is located in Centreville. This example of universal design is a good step forward toward a more inclusive playground. The pathway to the playground is level and offers a route for anyone using a wheeled mobility device. In addition, access to the play structure is also inclusive. A ramp is provided for anyone who wishes to go up onto the structure. The ramp offers an upper and lower railing and is colour contrasting for those with limited vision.

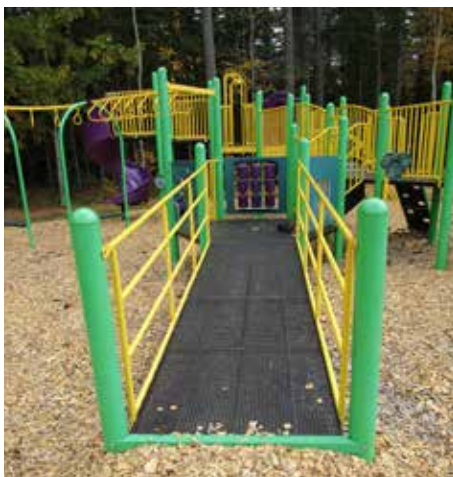
**KA 15** | Ramp leading onto an accessible playground structure

The accessible playground is a great addition to the county, but could still be improved. The wood chips that line the ground can get caught in wheelchair spokes. With heavy rain or snow, pooling might occur if a hole was dug by a child in the wood chips.

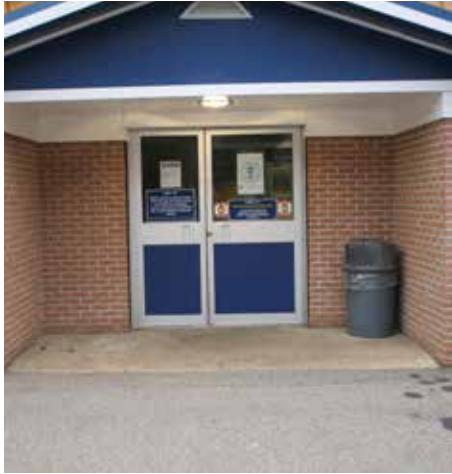
**KA 20** | Kingston Recreation Centre entrance.

The recreation centre entrance in the village of Kingston is in need of an accessibility upgrade. The existing door handles on the front entrance are not access friendly as they require full dexterity to pull. The entrance also does not have push access. The entrance is also on a slightly sloped podium that could cause unknowing users to stumble. Some elements are good on the entrance such as the outdoor lighting and the protection from elements.

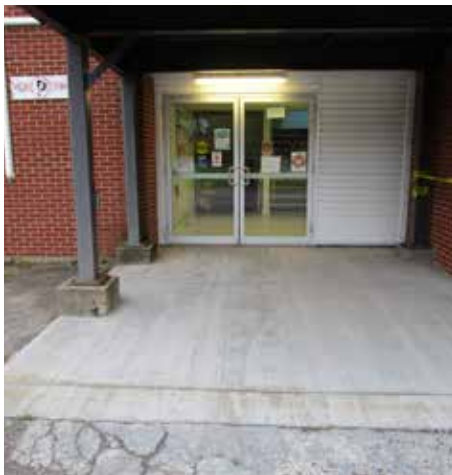
**KA 22** | Accessible entrance at the Wee Folk Centre in Greenwood

The Wee Folk Centre in Greenwood does not have an accessible front door. The main entrance is located on a platform with a single step up. This step up has no visual indication and could pose a tripping hazard to those with reduced visual ability.

There is a secondary entrance on the building that is accessible. The accessible entrance has a push button that is located outside of the door swing. In addition, a low slope brings users to the door. Attention could be given to the ramp as the surface is beginning to show signs of disrepair.

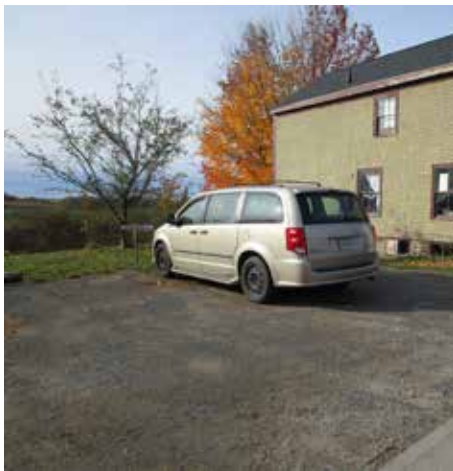
**PA 3** | Parking at Canning Library

The parking at the Canning Library does not have an accessible parking stall. The reserved signage is not clear as to who the stall is reserved for. Misinterpretation can easily occur and further direction is needed. The parking lot does not contain marked parking or signage and no clear access aisle is present.

Provide accessible parking spaces for expected use adjacent to accessible building entrances. Spaces should be 2600mm wide, with a 2000mm painted access aisle. All spaces should be provided on a firm, level surface with signage painted on the pavement and displayed vertically, on a post at the head of the stall. It is also important that these stalls are not misused by those who don't require them. A permit system is recommended.

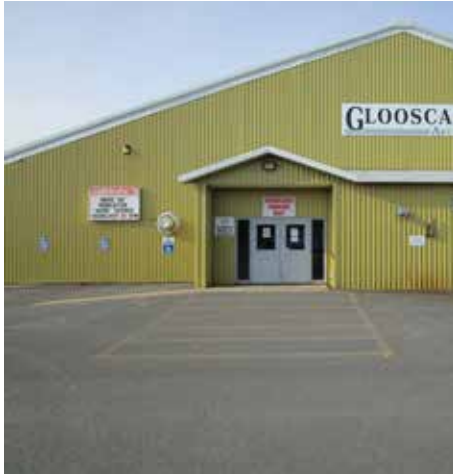
PA 4 | Accessible parking at Glooscap Arena

The accessible parking at the Glooscap Arena is present and for the most part is well designed. The issues found with the overall design include the slope of the stall itself. When an accessible parking stall is sloped it can effect whether the personal vehicle lift will operate. In addition, the signage on the wall is contradictory as it states "No parking" while also being the accessible parking stall. Finally the separated path to the entrance is elevated slightly with a lip. The original design probably did not intend on the lip being present but it is currently a tripping hazard.

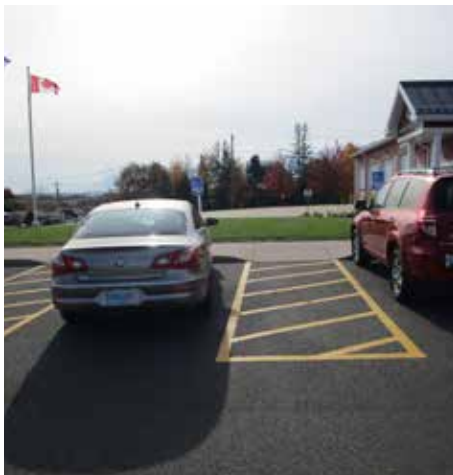
PA 6 | Parking at Canning fire hall

The parking at the Canning Fire hall is a very good example of accessible parking. Well defined accessible stalls are immediately visible and adjacent to the building entrance. All accessible stalls have a dedicated access aisle and curb cut. The pathway to the front is clear and wide enough for passing of wheeled mobility devices.

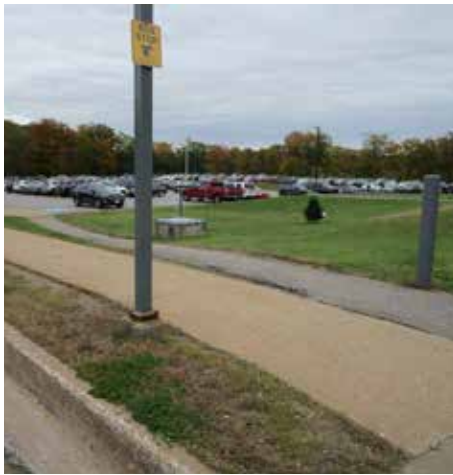
**PA 8 |** Sloped path to parking lot leading away from Hospital

Once at the top of the slope users will find that the pathway has no curb cuts. Without this, users in wheeled mobility devices would struggle to find the accessible path as there is no signage indicating a recommended direction of travel.

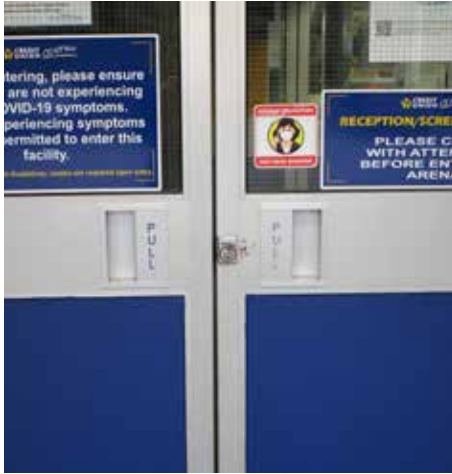
**WS 1 |** Credit Union Recreation Complex front entrance doors

The signage at the Credit Union Recreation Complex is colour contrasting and located at an appropriate height. The signage should be located on a wall instead of a doorway, this is to ensure a clear view even when the door is open. Finally, tactile characters and braille should be provided on the updated signage for those with reduced visibility.

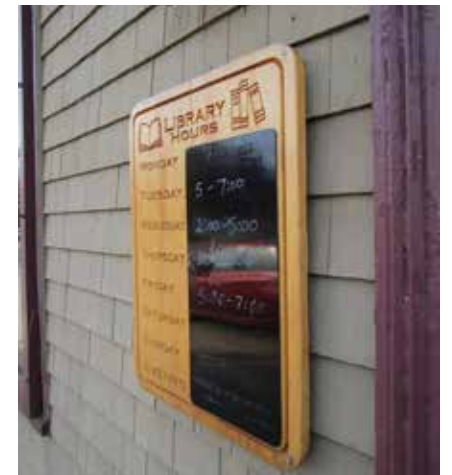
**WS 3 |** Front entrance sign at the Canning Library

The signage at the Canning Library is difficult to read due to wear and reflection/ glare on the surface. The sign also lacks tactile characters and braille. Colour contrast between text and background is also lacking.

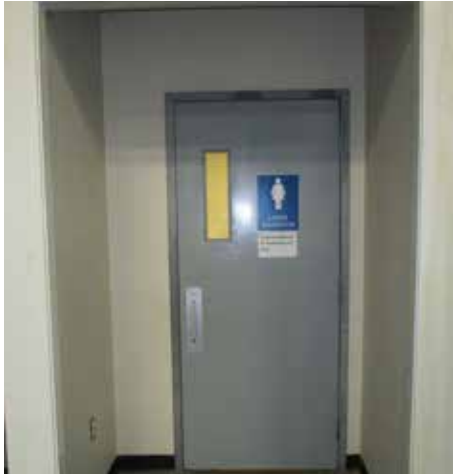
**WS 4 |** Womans washroom door at Glooscap Arena.

Washroom signage is an important information source for anyone wishing to use the facilities. If signage is on a door users might not see it if the door is propped open. In addition, there is no indication on the signage on whether or not the washroom is accessible.

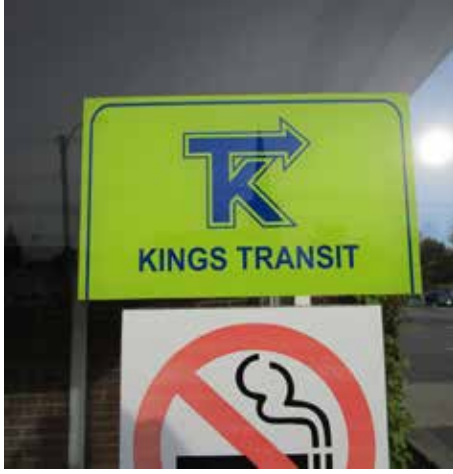
The sign in image WS6 was found on the interior of a bus shelter, above eye level. Visibility of the sign is sometimes difficult due to the reflection and glare coming off of the glass. The colour contrast between the font and background is good and with repositioning the sign would be more accessible. Braille should be added to the signage as well.

**WS 6 |** Bus stop signage

Signage should include specific route and contact information to check timing for the next bus arrival. It is also recommended that tactile and braille signage be provided at 1200mm height.

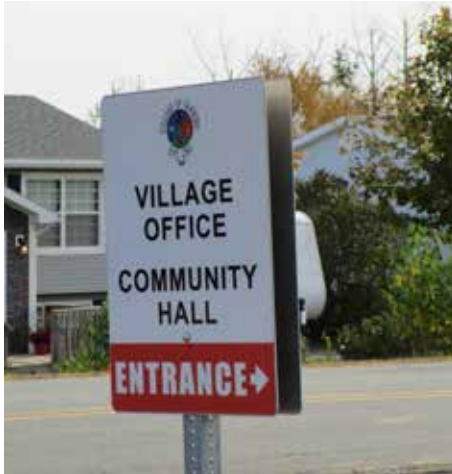
WS 7 | Kingston Village office entrance sign

The directional vehicle signage at the Kingston village office helps to increase accessibility and wayfinding. The sign is colour contrasted and uses a font that is readable at a distance. The directional indication helps users know where to go when visiting the village office and community hall.

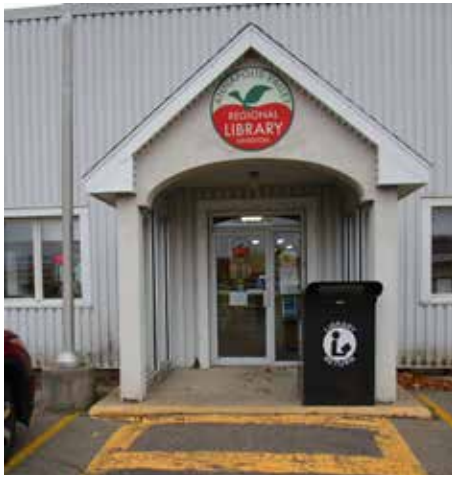
WS 8 | Kingston Library entrance sign

The library exterior signage is good for colour contrast but lacks in a few elements. The sign has no lighting facing it and it is hard to see at a distance and in dark conditions.

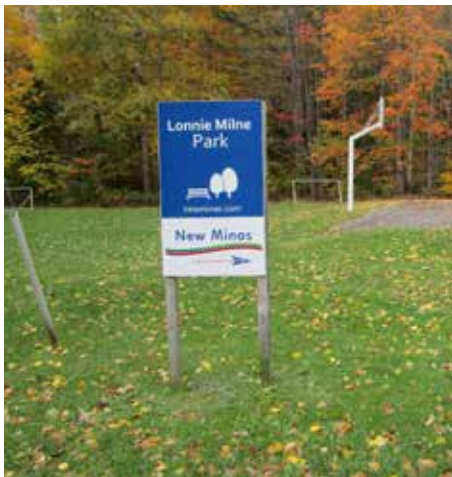
WS 9 | Lonnie Milne Park outdoor signage

The sign seen in image WS9 shows a typical outdoor sign for parks in Kings County. The colour contrast on the sign is good for those driving or walking. A helpful addition to the sign would be a map of destinations within the park along with tactile characters.

Tactile braille should supplement the text of regulatory, warning, and identification signage. All public buildings with outdoor signage at pedestrian level should have braille describing the building accessibility conditions and constraints.
